The device for monitoring the LED display high-voltage insulators state

To cite this article: R N Balobanov *et al* 2019 *IOP Conf. Ser.: Mater. Sci. Eng.* **552** 012011

Abstract. The article discusses the possibility of using devices for monitoring the state of high-voltage insulators with LED indication, mounted on insulating structures of high-voltage lines and substations. The scheme of the device is given and its principle of operation is described. The feasibility of indicating the early stage of the an insulation defect development in a laboratory and full-scale experiments on real power system facilities using devices with LED indication are shown. A new method of insulation control using the developed device will allow, when visually inspecting an overhead line, to additionally provide information about the change in the electric field and the appearance of discharges in the insulation. In addition to the early warning of the birth of a defect, this information will be useful for routine maintenance (cleaning) of insulators.

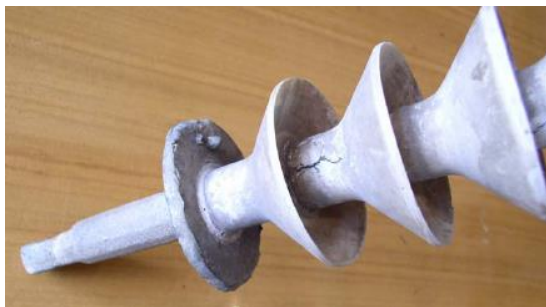
Figure 3. Erosion of the containment shell

1. Erosion of the shell and the formation of a track on the outer surface of the protective shell of the insulator figure 3. This defect may occur during the operation of insulators in areas with severe contamination due to the impact of surface discharges in wetted insulators.

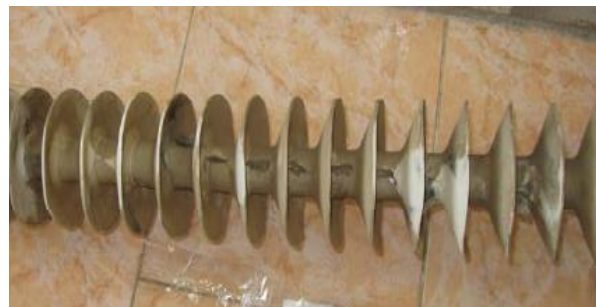
Figure 4. Breakdown of a linear polymer insulator on HVL 330 kV

2. Formation of dendrites in a fiberglass rod and tracks at the interface of the "core-shell" section in a polymer insulator figure 4.

Often this is accompanied by an internal erosion of the containment up to the formation of through holes. This damage is also associated with the penetration of moisture into the insulator. The root cause of damage is most often a defect in the design of the insulator, namely:

- insufficient tightness of the interface between the shell and metal reinforcement;
- poor adhesion of the shell to the fiberglass rod.

In addition, the leakage may be due to damage (breaks) of the shell during transportation of insulators or installation.

According to the operating experience, this type of damage to polymer insulators is the most common. The breakdown of the insulator is accompanied by the occurrence of an electric arc with the destruction of part of the protective sheath.

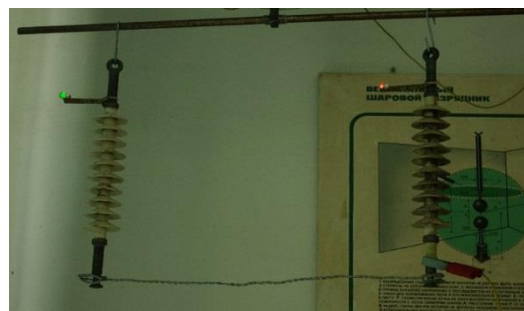
Figure 5. Image of defective and serviceable polymer insulators with LED indicators mounted on them

Similar defects were simulated in the laboratory. In the picture (Fig. 5), two polymer insulators LC 70/35 are shown, to which AC voltage was applied from 0 to 25 kV. One of the insulators (right) has a defect in the form of a longitudinal conducting channel that shunts a part of the structure (~ 30%), and the second (left) is serviceable. LED indicators are attached to the upper electrodes of both insulators.

When the voltage was raised, it was clearly observed on the one hand, the increase in the pulse repetition rate of both indicators, and on the other, the pulse repetition rate on the defective insulator was

noticeably higher. When a voltage of 20 kV was reached, pulses of a red LED appeared on the indicator mounted on the defective insulator. On a good insulator, the green LED pulses continued.

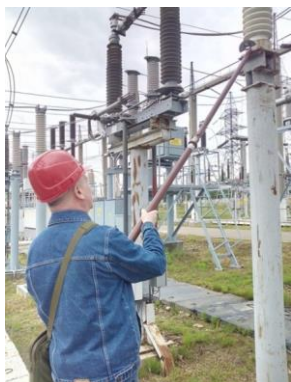
Figure 8. Order of work

The results obtained in the laboratory, allowed to go to full-scale experiments on real objects of the power system. The tests of the indicators took place in the 110 kV outdoor switchgear of the Kazan CHP-3 (OJSC TKG-16). The defect indicator was mounted on an insulating rod and was brought into contact with a grounded part of the supporting insulators by a single electrode (Fig. 8). On the inspected support insulators, as can be seen in Figure 9, the indicator glow was sufficiently bright for visual detection in sunlight.
